# A PHASE I ENVIRONMENTAL SITE ASSESSMENT

Former Western States Plywood Cooperative Mill Property Tax Lots 104, 900, and 901 Vicinity of 93639 Elk River Road Port Orford, Curry County, Oregon

November 14, 2022

HAI Project No. 9889

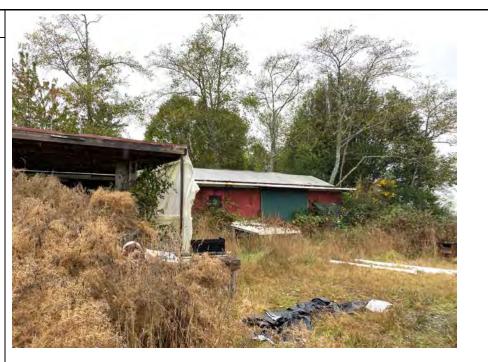
#### Photograph No. 1

**Comments:** View of the vacant Storage / Maintenance Building, which is becoming overgrown and difficult to access. Awning to left, shed to right.

The vacant Storage/Maintenance Building was wood-framed and had a concrete slab foundation and a wood exterior (Photograph No. 1). The building had unfinished walls and a concrete slab floor, with *de minimis* oil staining noted in places on the concrete floor (Photograph No. 2). Fluorescent light ballasts were present throughout the structure. The building was largely empty at the time of the site visit aside from a metal file cabinet and some disassembled wooden furniture. Hazardous materials were not observed within the structure. One small room was visible, but was not able to be inspected. According to Mr. Ted Labbe of Elk River Partners LLC, the subject property Owner, hazardous materials were not present within the room (refer to Section 5.1 *Interviews with Owner, Site Manager, Occupant*.

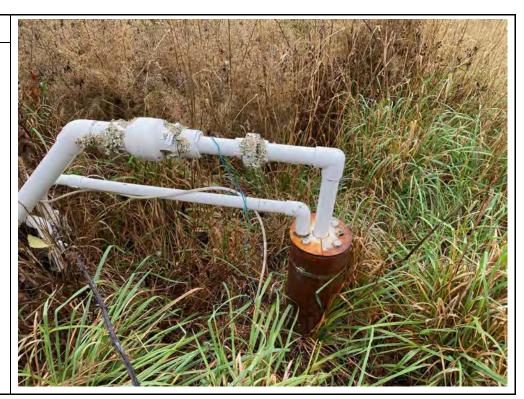
**Comments:** Water well with PVC piping. Not in use at time of site visit.

One water well was observed at the subject property, on Tax Lot 900. The well is discussed in Section 4.8 *Wells.* A review of Oregon Water Resources Department (OWRD) records revealed one water well log for the subject

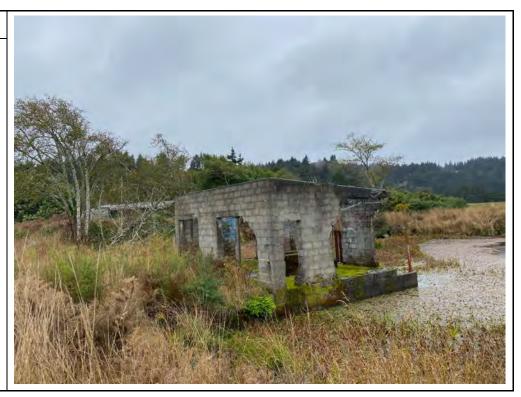
## Photograph No. 4

**Comments:** Concrete and steel remnants of the old Fire Pond pump house.

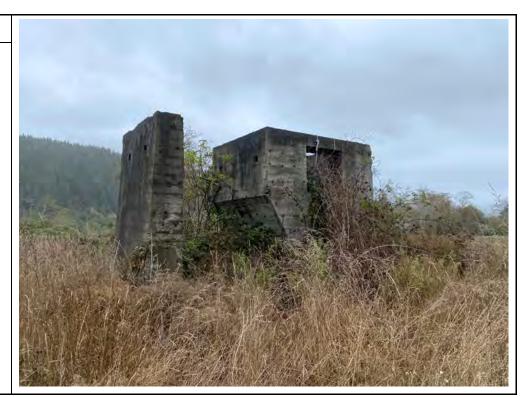
**Comments:** Concrete remnants of old boiler house.

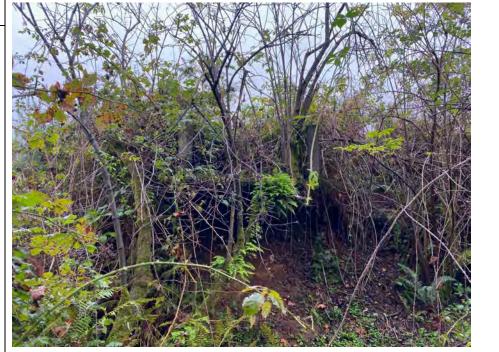
# Photograph No. 6 Direction: South

**Location:** Northern boundary of the Log Pond

**Comments:** Dense vegetation and remnants of small concrete canal located above Bagley Creek on the northern portion of the Log Pond.

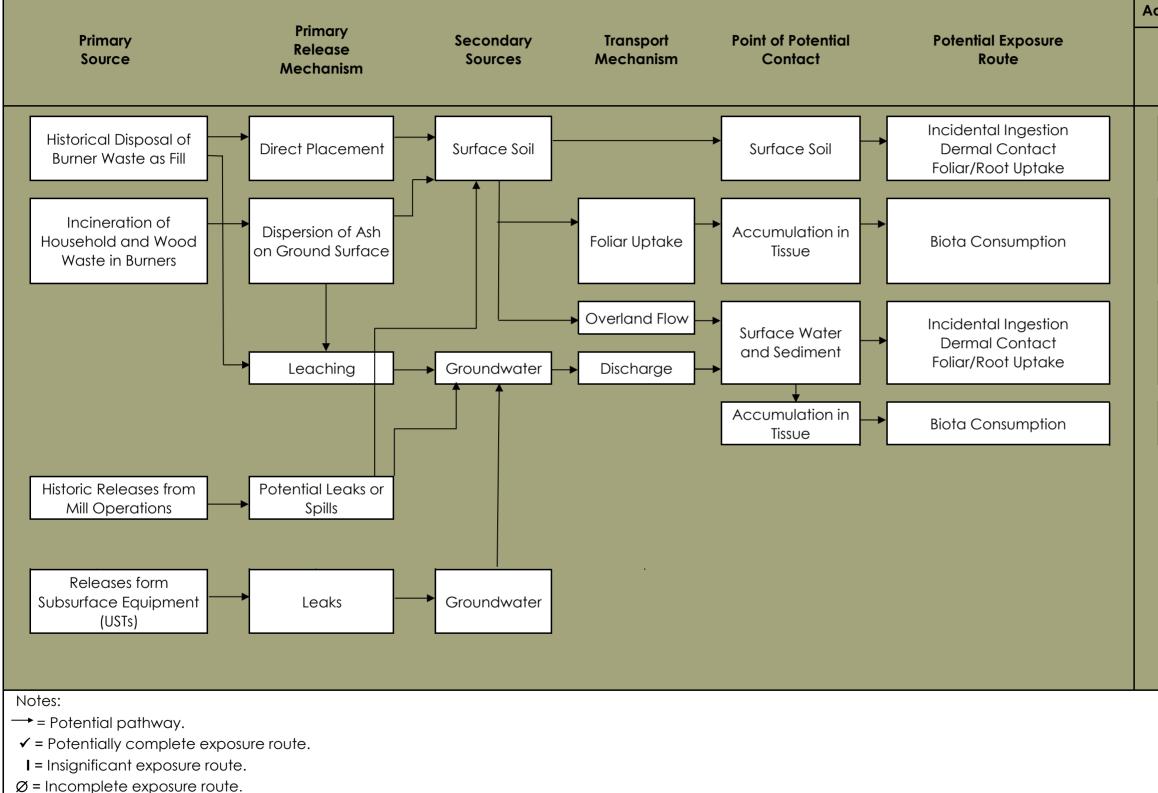
Mr. Dougherty indicated that he was not aware of:

- Other historical uses of the property or of any former property structures other than the former Western States mill.
- Any existing or former USTs, ASTs (aside from glue ASTs), water supply wells, septic tanks, drywells, pits, sumps, or hazardous substances and/or petroleum product usage on the property
- He was not aware of wood treatment chemicals being used onsite, and was not aware of any chemical usage other than glue
